## Root Cause Classification of Breakup Events 1961-2018

P. Anz-Meador<sup>(1)</sup>

This paper uses the updated NASA “History of On-Orbit Satellite Fragmentations 15th Edition,” to examine and categorize the root cause of historical breakup events to the greatest degree possible. Classes of debris progenitors have evolved, as many classes of Cold War-era spacecraft are now extinct, only to be replaced by new classes of payloads and rocket bodies statistically likely to experience debris-producing events. The efficacy of international debris mitigation implementation and root cause/fault tree analyses and lessons learned is examined in relation to the breakup of satellite classes or specific events. In select cases, the remaining on-orbit inventory of specific classes is identified in the context of possible future events. The environmental impact of these specific classes is examined and compared to nominal space environment projections. When appropriate, recommendations for debris remediation are made for specific satellite classes.

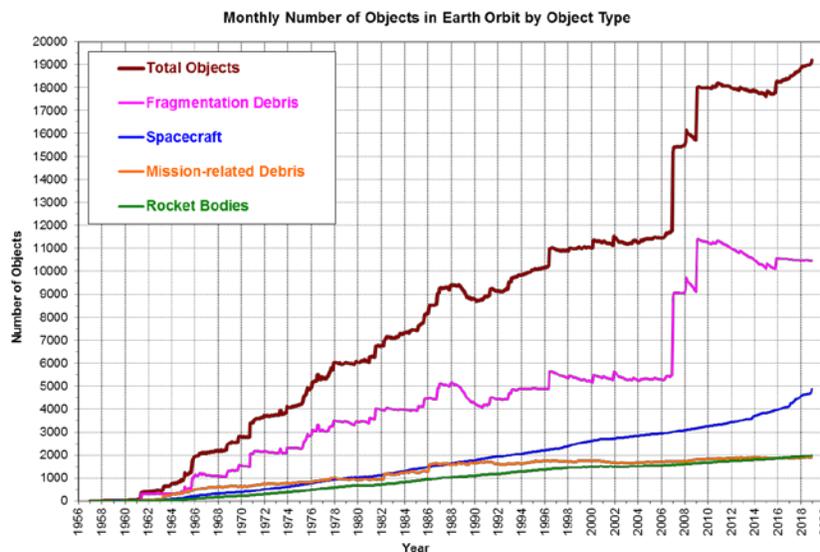
Fig. 1. The growth of debris populations over time. Major breakups show sudden “jumps” at the date of breakup.

Figure 1 shows the growth over time in the number of catalogued objects, including debris. Note that for the purposes of this chart, debris objects that were identified and catalogued by the U.S. Combined Space Operations Center (CSPOC) some length of time after the breakup (even years later) were “back filled” to the time of breakup. Large breakups show “jumps” in number, with a gradual decay as the debris are gradually removed from the environment due to atmospheric drag.

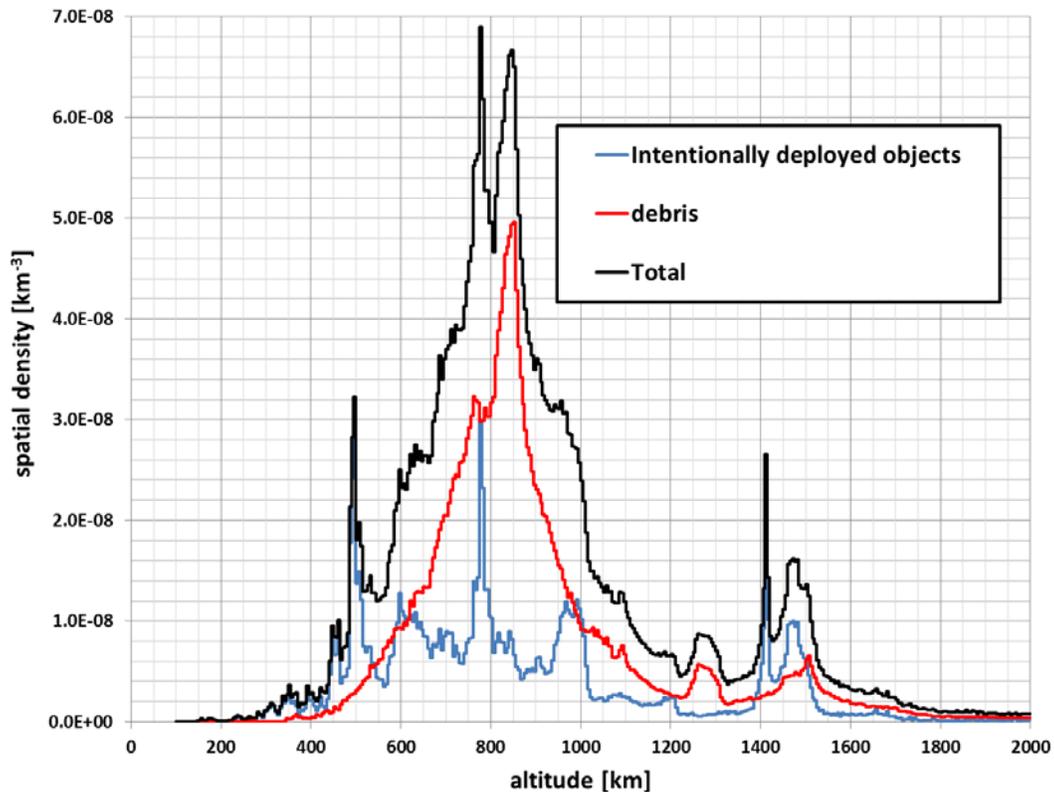
Fig. 2. The relative population of debris and intact objects at various altitudes. From about 600 km to 1400 km altitude, debris is the major contributor to the population of tracked objects (> 10 cm in size).

Another way to understand the debris distribution is to plot it as a function of altitude. Figure 2 shows this distribution of trackable objects, using the concept of spatial density – where the volume is a spherical shell around the Earth – and the number is weighted by the fraction of time the orbiting object spends at each altitude. Debris dominates the orbit population between about 600 km and 1400 km altitude.

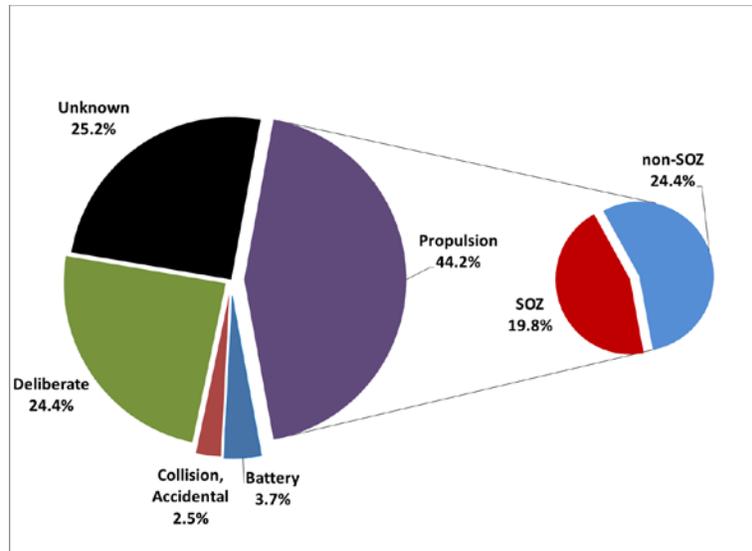
Fig. 3. This pie chart shows a proportion of various historical on-orbit breakup causes. The largest category of breakups is due to propulsion-related events, although a significant fraction of these is due to a single type of rocket body – the Russian SOZ units. Most of the deliberate events were intentional self-destruction of Russian military satellites before the 1990s. Note the significant fraction of breakups where the root cause was never uniquely identified.

Using the HOOSF data, it is possible to accrue statistics on the causes of the various breakups, as shown in Fig. 3. Note that a largest category of (known) breakups consists of propulsion-related explosions. However, nearly half of those are due to explosions of a single type of rocket body – the Russian SOZ (*Sistema Obespecheniya Zapuska*) units from Proton 4th stage ullage motors. Cause – in isolation – however, is insufficient to understand the temporal behavior of orbital debris generation, as technology, practices, and operations evolve over time. Figure 4 presents Fig. 3's events over time.

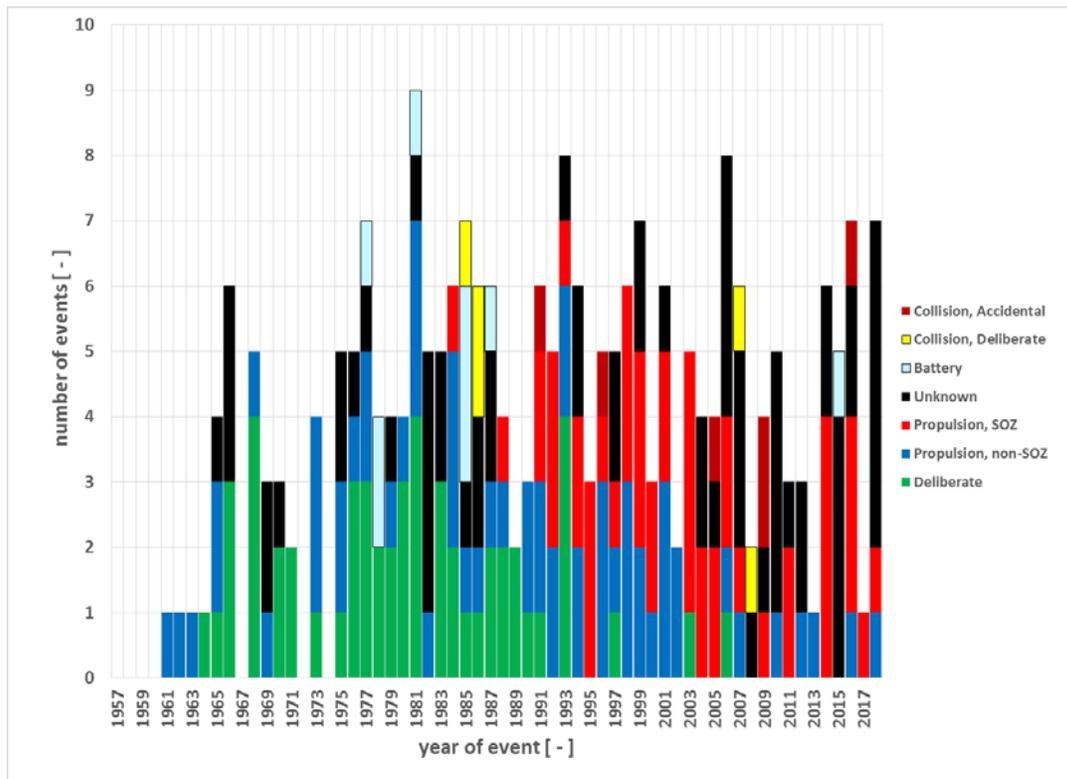
Fig. 4. Cause attribution by time. The largest category of breakups is due to propulsion-related events, although a significant fraction of these is due to a single type of rocket body – the Russian SOZ units. Most of the deliberate events were intentional self-destruction of Russian military satellites before the 1990s. Note the significant fraction of breakups where the root cause was never uniquely identified.

Figure 4 clearly identifies several salient features of debris production. Most of the deliberate breakups are due to a number of Soviet military satellite self-destruct events before the 1990s. These were motivated by payload recovery concerns (*i.e.*, payloads whose recovery within the Soviet Union was uncertain were destroyed on-orbit), apparent end-of-mission activities, or loss of signal. No deliberate explosions have occurred in the last decade. Rather, this category has been supplanted in its entirety by a lone battery-related breakup, propulsion-related explosive breakups (including those of SOZ units), and accidental collisions. Failures due to causes unknown remain a major contributor to the overall yearly totals over the last decade.

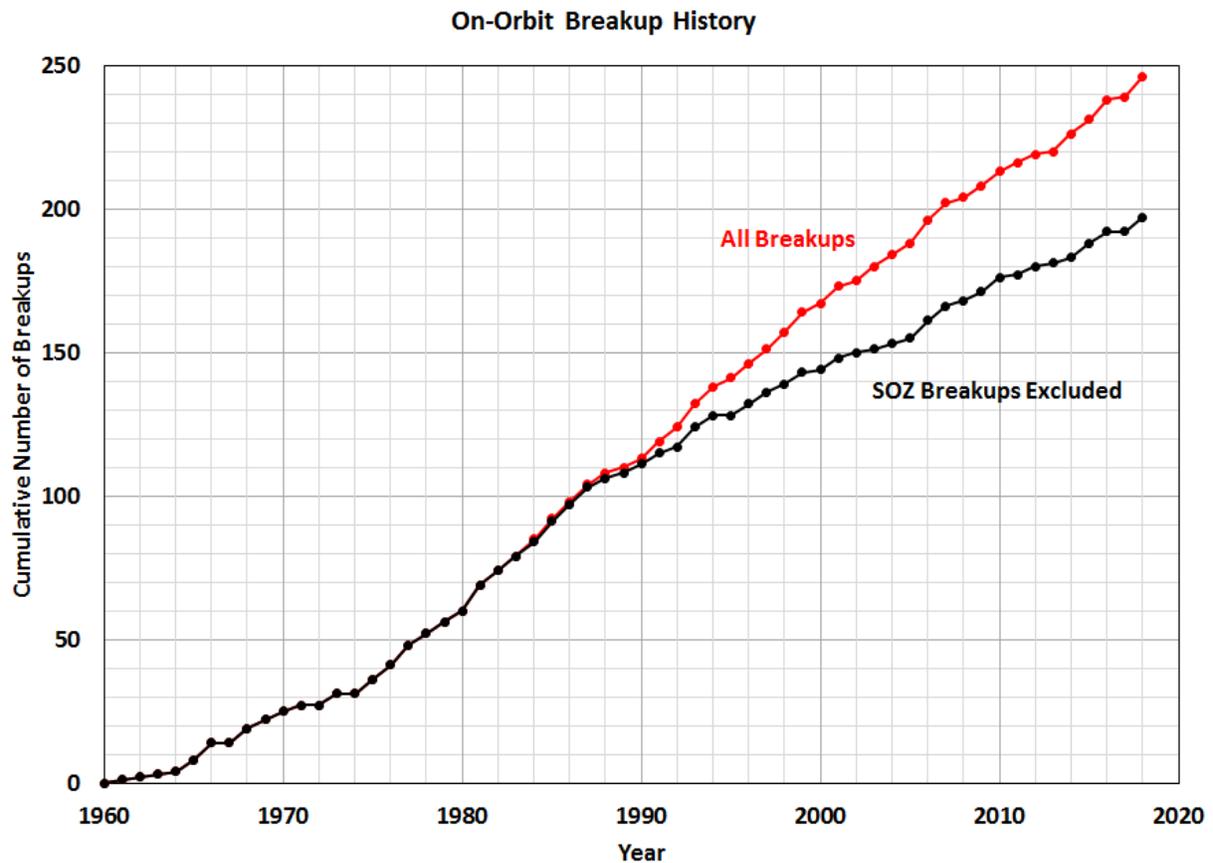
Fig. 5. Here, the data from Fig. 3 is plotted as a cumulative distribution, this time both with and without the SOZ breakups included. Note that ongoing SOZ breakups mask a noticeable reduction in explosion rates of other satellites beginning in the late 1980s. This is the time when widespread mitigation measures were implemented on a regular basis. Because the SOZ units are a “grandfathered” system (see text), they exhibit a similar slope to the steeper pre-mitigation fragmentations of the 1970s and 1980s.

It is important to note that the SOZ statistics mask the history of other types of breakups. Figure 5 shows the breakup history from Fig. 3, but in a cumulative form, plotted both with and without the SOZ breakups. In the curve without the SOZ breakups, there is a noticeable change in slope in the late 1980s that corresponds to the beginning of widespread mitigation activities, primarily due to efforts by NASA and other agencies to educate the space community and implement mitigation standard practices. In essence, the SOZ units were a “grandfathered” system with known issues, but where no mitigation changes were made. Despite the reduction in fragmentation rate due to mitigation practices, fragmentations continue, albeit at a reduced rate. When a satellite or upper stage shows a pattern of fragmentation, changes are typically made to correct the problem for future launches. However, new systems or updates of older systems are continually being deployed, which sometimes introduce new failure modes that must be remedied.

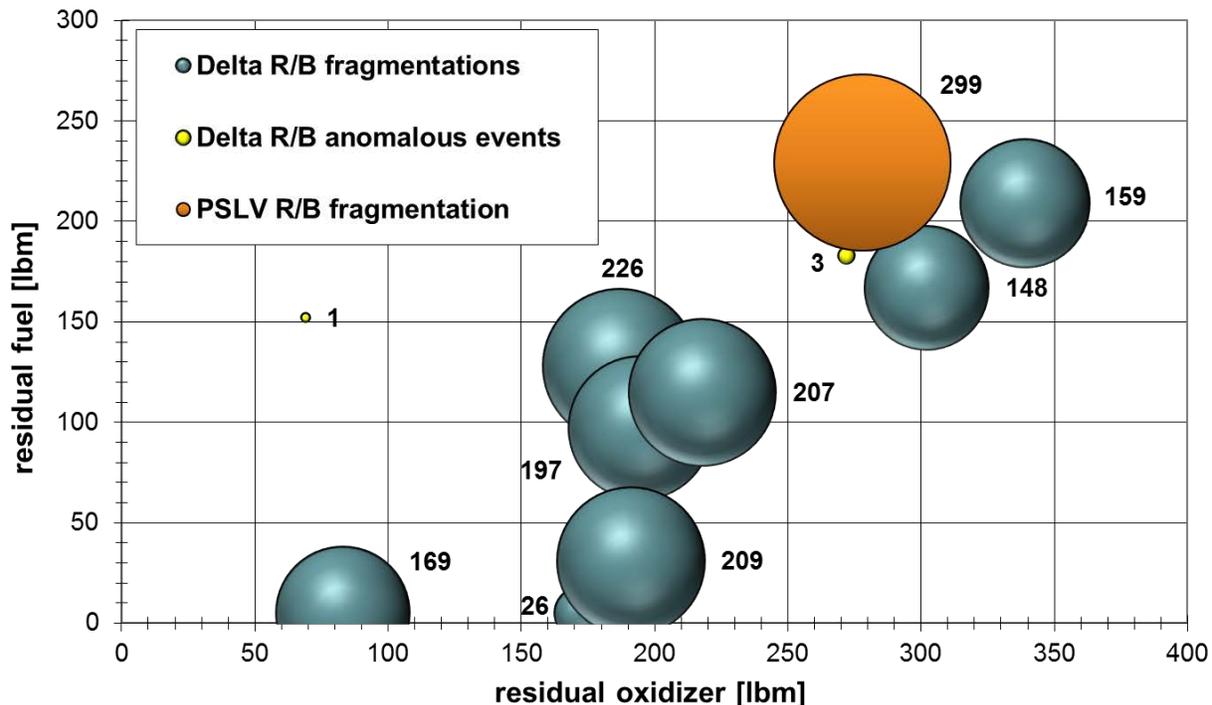
### Cataloged Debris as a function of Residual Propellants

Fig. 6. The relative number of tracked debris of several explosions (shown graphically as size of the circles) as a function of both residual fuel and oxidizer. The low correlation between cloud size and amount of remaining propellants suggests a very inefficient explosion process.

The next case study concerns the U.S. Delta and Delta II second stages. The first identified fragmentation of this rocket body was Delta 62 in November 1973, and many more major LEO events followed. The manufacturer examined all available data, including estimates of the residual propellants on each stage [3], and concluded the breakups were caused by a mixing of the residual hypergolic propellants due to breaching of the common bulkhead, leading to an inefficient explosion. Studies by the NASA Orbital Debris Program Office and imaging by German radar of the Landsat 2 rocket body confirmed that large hulks remained in orbit after the breakups, corroborating the hypothesis of inefficient explosions. Figure 6 shows the debris cloud sizes of the Delta breakups (and one Indian Polar Satellite Launch Vehicle [PSLV] breakup) as a function of remaining fuel and oxidizer. The low correlation of debris cloud size to available energy also argues for inefficient mixing of the propellants in an explosion.

While no single cause fits all the historical Delta second stage fragmentation data, the highest-likelihood attribution is to mixing of hypergolic propellants through a breach in the common bulkhead separating the fuel and oxidizer tanks. With this attribution, now-standard mitigation practices were introduced with the launch of Delta 155 in August 1981. These practices consist of disabling the range safety ordnance and burning remaining propellants to depletion during a payload evasive burn or, expending propellants by starting the main engine and holding propellant valves open for one minute and venting the nitrogen-gas ullage jets for five minutes. Figures 7 and 8 illustrate the effect of mitigation procedures upon the second stage.

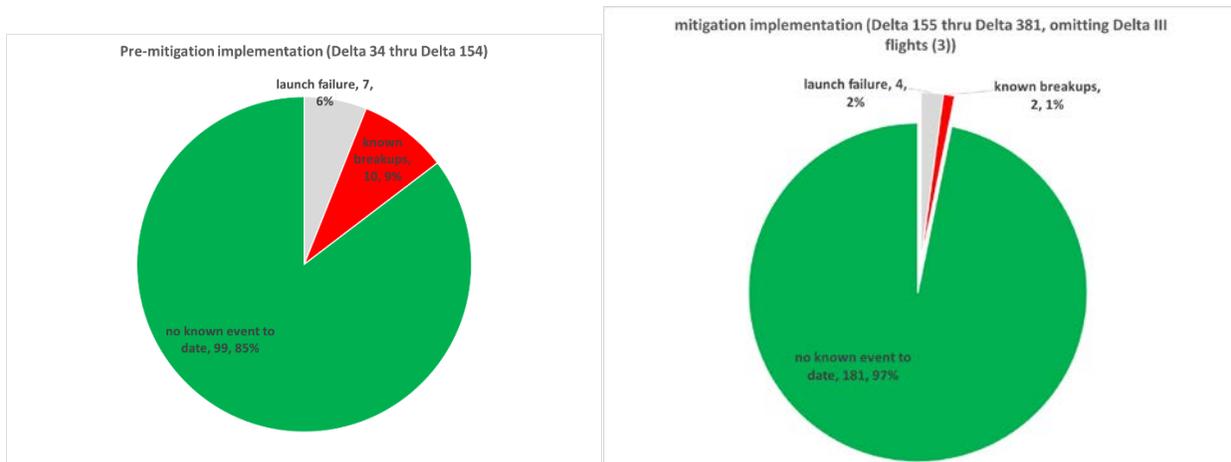
Fig. 7. Breakup events pre- (left) and post-implementation (right) of mitigation standard practices.

Prior to this mitigation-driven operational procedure, Delta flights 34–154 inclusive experienced 10 known breakups, for a 9% rate. Afterwards, Delta flights 155–381 inclusive (but omitting three flights of the Delta III model) experienced only two known breakups, for a 1% rate. However, noting the number of debris cataloged in the pre- and post-mitigation operational regimes, pre-mitigation flights produced 1786 (98.13% of the total cataloged) debris while post-mitigation flights produced only 34 (1.87% of the total cataloged). Further, examining debris remaining on-orbit as of 4 July 2018, the information cut-off date of the 15th edition of the NASA “History of On-orbit Satellite Fragmentations,” 1073 (99.814% of remaining cataloged debris) pre-mitigation flight debris remain, versus only two (0.186%) for post-mitigation Delta fragmentation events. The significantly different nature of the post-mitigation events argues strongly that, indeed, the operational procedures for stage passivation introduced with Delta 155 resulted in a complete success in addressing the highest likelihood fragmentation scenario.

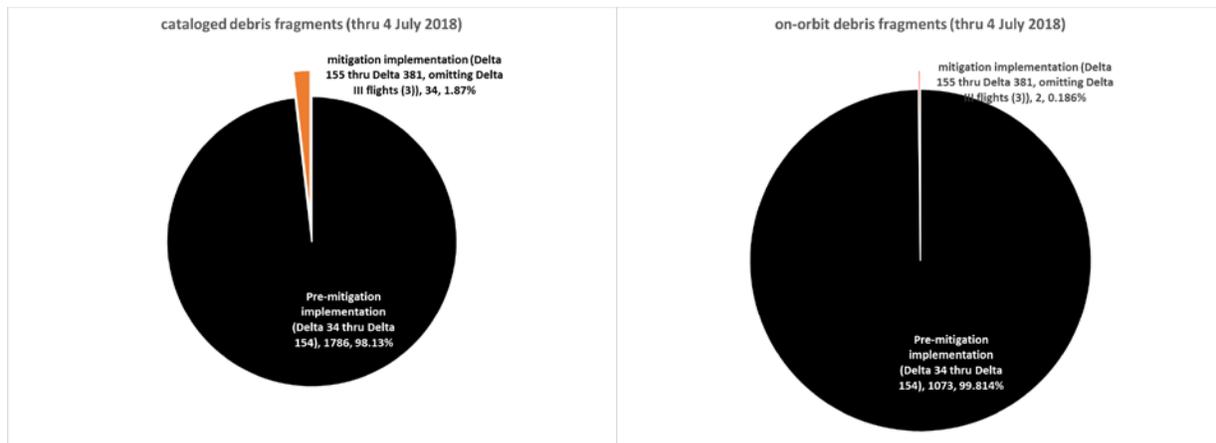
Fig. 8. Pre- (black) and post-implementation (orange) debris cataloged (left) and on-orbit (right).

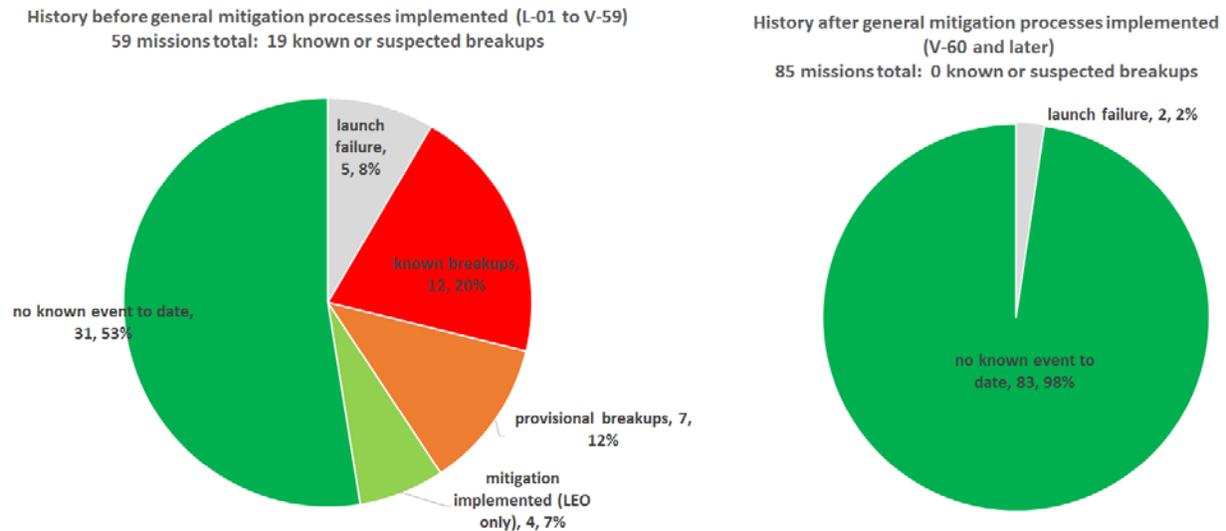
Fig. 9. The proportion of observed or suspected Ariane fragmentations that occurred before and after mitigation procedures were generally implemented. When LEO mitigation was implemented (left chart), no more explosions occurred, and when general mitigation procedures were implemented in all flights (right chart), no more on-orbit explosions occurred.

The manufacturer examined the available data, and was able to exclude causes due to battery explosions, accidental initiation of range-safety explosives, a mechanical breakup due to venting-imparted spin, or electrostatic discharge. Possible root causes included a common bulkhead reversal due to hydrogen or oxygen tank leakage, or rupture of the hydrogen tank due to structural fatigue induced by the orbit day/night thermal cycle. Mitigation practices were first introduced for the launch of SPOT-2 in 1989 (flight V36). These procedures consisted of vehicle reorientation after final payload separation, followed by irreversible opening of the oxygen vent valve [4, 5]. After a “proper time lag,” the pressure release valve on the hydrogen tank was opened irreversibly. Figure 9 graphically shows the effects of mitigation procedures on the rate of explosions.

From the lessons learned with the Ariane program, Ariane 5 became the first launch system where passivation of the upper stage was part of the engineering requirements and designs from day one. Other legacy systems have had to change pre-existing designs to limit explosions.
